# Manhole Inspection Summary

Manhole # S35AA\_029MH

**Inspection** ☐ Is Incomplete Rating: **5) Immediate Attention Required**

**Location** Address: **cross from 211 guilford av** Cross Street: **e monument st**

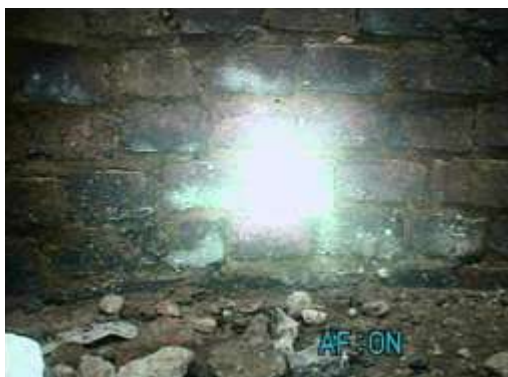
Misc

**Bench** ☒ Exists Material: **Brick** ☐ Parged  
Condition: ☒ Sound ☐ Cracked ☐ Root Intrusion ☐ Deteriorated ☐ Leaks ☐ Debris

bench debris

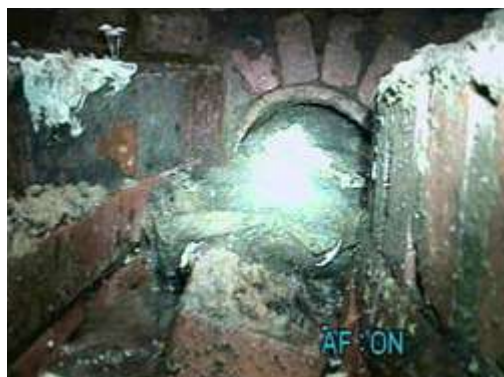
Defect 3

**Channel** Material: **Brick** ☐ Parged  
Channel Exposure: **Fully Open** Junc Dist: **0** nearest .5 ft. Azimuth: **0**  
Condition: ☐ Sound ☐ Cracked ☐ Root Intrusion ☐ Deteriorated ☐ Leaks ☒ **Debris**

channel debris

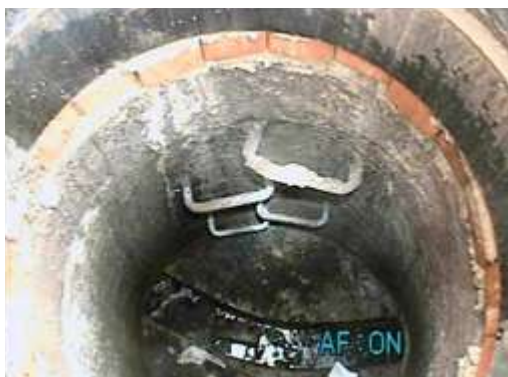
Defect 1

**Steps** Count: **4** Missing: **0** ☒ **Corroded**

corr steps

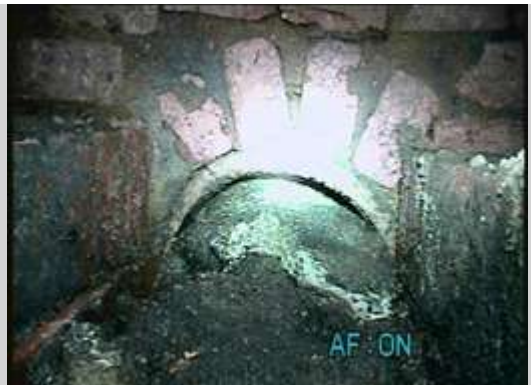
7 O'Clock Inflow

8 in. Circular Gravity Sewer  
Pipe In @ 7 O'Clock

Deposits: ☐ None ☐ Mud ☐ Sludge ☒ **Debris** ☐ Grease

Silt Depth: 0 (in.) Deposits Extent: **Heavy**
